Service Letter

BRIDGESTONE 350 GTR
ENGINE REPAIR

BSG-0070

BS350GTR

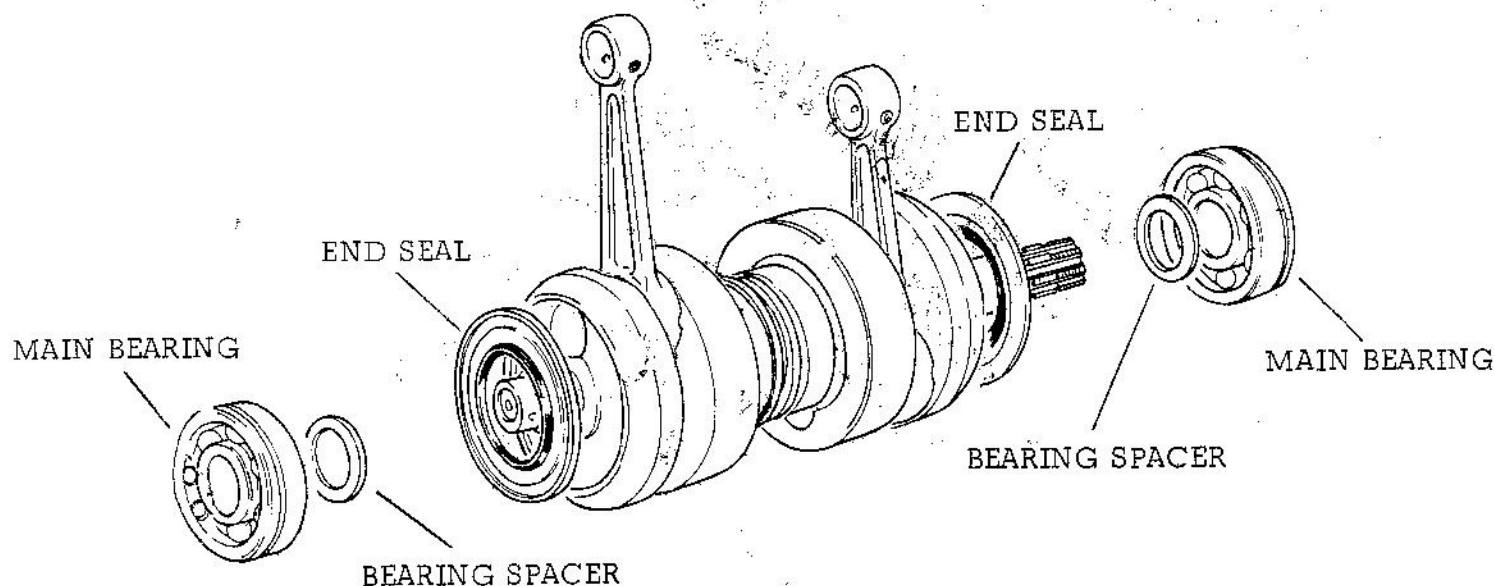
NOTE: The locating ring groove in the right bearing must be to the outside of the crankshaft so that when the crankshaft is installed into the crankcase the right bearing locating groove is aligned with the locating ring in the crankcase. The groove in the left bearing does not align with the locating ring in the crankcase. This locating ring retains the left bearing by positioning against the outer edge of the bearing rather than in the groove.

While the crankcases are apart, remove the crankshaft from the crankcase. Pry the two end seals from their recesses in the crankshaft. Then cut the edges of the end seals and remove them by pulling them from behind the main bearings. Do not reinstall new end seals.

NOTE: If the end seals have been damaged or are difficult to remove, examine the end seal recesses in the crankshaft to be sure there are no pieces of the end seal left which might damage the engine. To examine the end seal recesses in the crankshaft, pull the main bearings from each end of the crankshaft and then remove the two bearing spacer washers.

After examining the recesses to be sure they are clean, reinstall the spacer washers and bearings.
